MNMM Fatal 2006-04

- Electrical
- April 3, 2006 (Tennessee)
- Crushed Stone Operation
- Electrician
- 50 years old
- 11 years mining experience

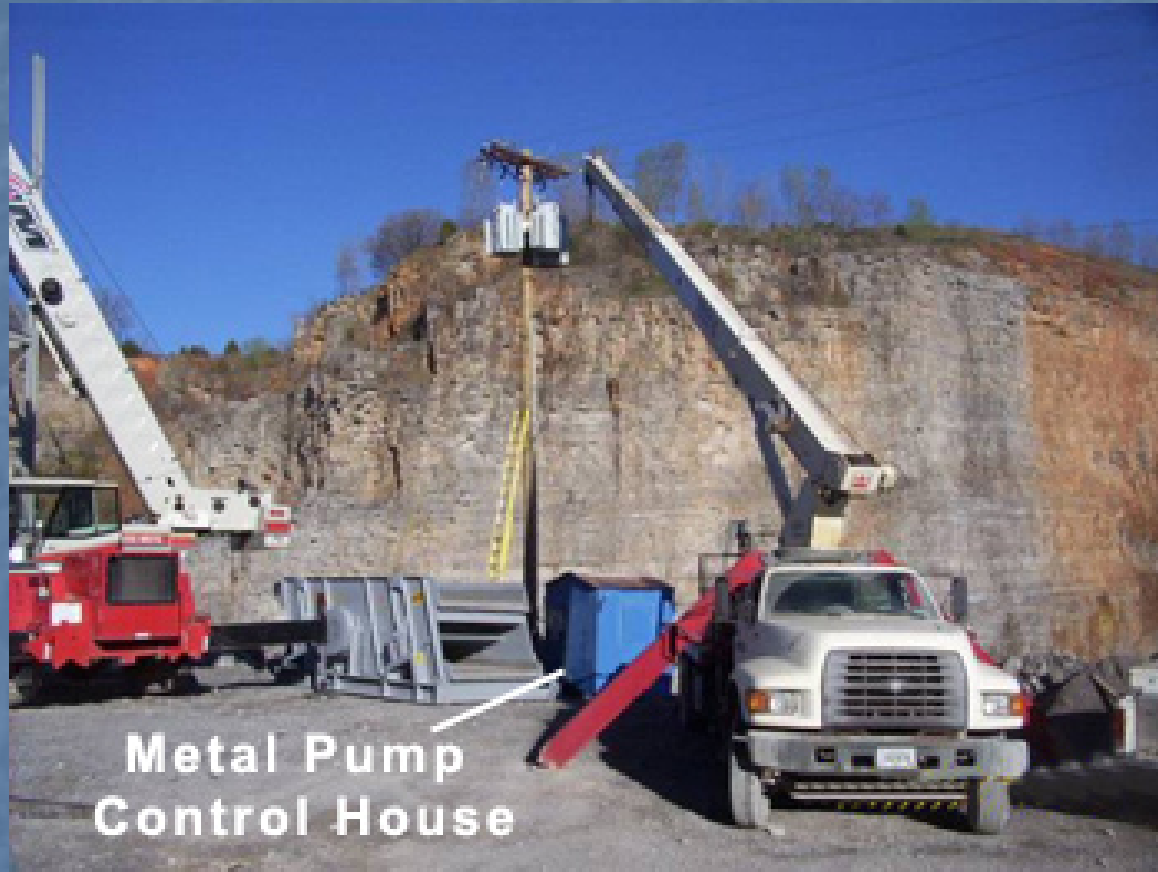
**Metal Pump
Control House**

The victim received a fatal electrical shock while pushing against a metal building that was suspended from a boom truck.

- Management policies and controls were inadequate and failed to require that steps were taken to determine if the overhead power line was deenergized before starting the task. There were no safe work procedures implemented to ensure that persons were protected while operating equipment near energized high-voltage power lines.
- Policies and controls were inadequate. Management failed to communicate and document the recent actions that resulted in power being connected to the newly installed overhead high-voltage lines.

- Stop, Look, Analyze, and Manage (SLAM) each task to identify all potential hazards before performing work.
- Ensure that high-voltage power lines are de-energized before operating equipment within 10 feet of them.
- Ensure that one person on the ground is designated to give signals to the crane operator making the lift.
- Ensure that miners are in a safe location prior to lifting the load.
- Non conducting tag lines should be used to steady loads when operating cranes where overhead power lines are present.
